Injection molding **Troubleshooting guide**

Eastman™ copolyesters

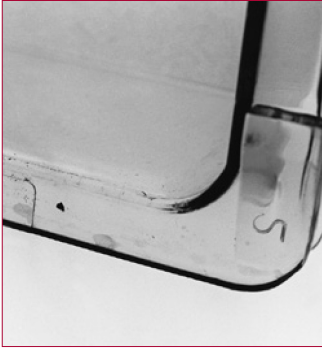
Black specks

Possible cause	Corrective action
Previous material(s) in the screw, check ring, hot runner, etc.	Purge machine with Eastman™ copolyesters or commercial purge compounds. If necessary, remove screw and manually clean the screw and barrel. Take the nozzle and hot runner apart and clean out previous materials.
Regrind contamination	Shut off regrind and mold virgin to test source of specks. Allow sufficient time to clear the screw, barrel, check ring, and hot runner.
Raw material contamination	Ensure any open boxes are covered while in use. Examine pellets for possible contamination.

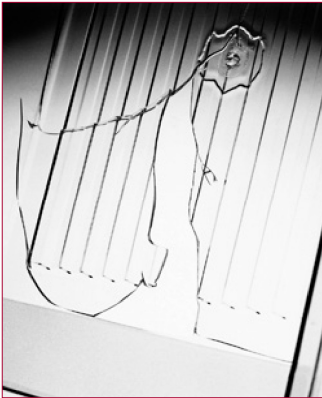
Brittleness

Possible cause	Corrective action
Poor drying	See processing guidelines for your copolyester formulations.
Excessive residence time	Calculate melt residence time by formula in molding guides. If >5 minutes, use smaller shot machine or reduce cycle time.
Melt temperature too high	Measure and reduce melt temperature.
Cracking when mold opens <ul style="list-style-type: none"> • Overpacking • Hot mold • Poor drying • Breakaway too fast • Needs vacuum break 	<ul style="list-style-type: none"> • Reduce either packing pressure or time. • Lower mold temperature or improve cooling uniformity. • See processing guidelines for your copolyester formulations. • Reduce mold-opening speed. • Install air poppet/vacuum break.

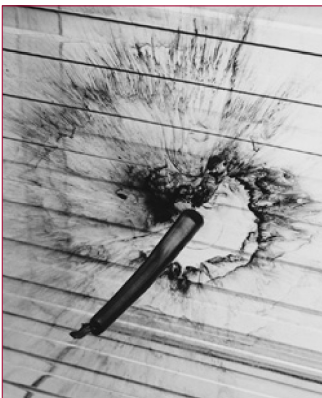
Discoloration

Possible cause	Corrective action
Overdrying	Follow recommended drying temperatures and times outlined on the product specification. If deviations are necessary, consult your Sales/Technical Representative.
Long melt residence time	If melt residence time (holdup time) is >5 minutes, purge machine before restarting, reduce cycle time, or use a smaller barrel capacity.
Contamination	Same as for haziness (see page 7).

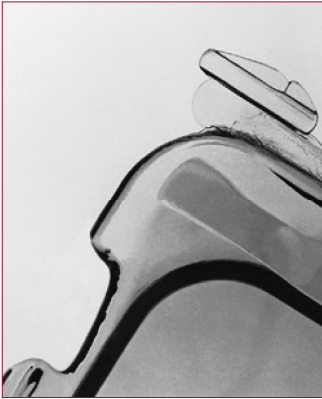
Flash and short shot in the same shot

Possible cause	Corrective action
Core shift	Check wall thickness for core shift. Investigate for sources of core shift and repair mold.
Inadequate clamp tonnage	Increase clamp pressure or move to machine with more tonnage.
Fill speed or pressure too high	Reduce speed or fill pressure.
Melt temperature too low	Check and raise melt temperature if needed.
Sprue too long or too small, "O" dimension	Install correct size sprue.

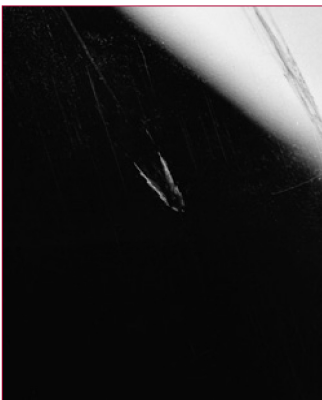
Flowlines vs. seagulls, hooks, heat marks

Possible cause	Corrective action
Gate and runner design	If marks are near the gate, locate and repair sharp edges and other high shear features. Increase gate size and radius all corners. In hot runners, look for hot and cold areas and cross-check temperature settings with a pyrometer when possible. Test the effects of raising and lowering individual temperature zones and reducing fill speed.
Temperature differences in the incoming material/flow path	Reduce temperature differences between the melt, nozzle, and runners. Ideally, take a melt temperature. Set nozzle and hot runner to that temperature, then adjust slightly. Check temperature inside the nozzle with a pyrometer.
Shear differences in the flow path	Eliminate shear differences caused by sharp corners, sharp edges, or abrupt changes anywhere in the flow path including the nozzle adapters, sprues and runners, gates, and part walls. Adjust and profile injection speed (slower when high shear defects are formed).

Part wall thickness, gate location, or fill pattern causing flow stoppage or hesitations	Mold a series of short shots to see how the defect forms. Measure wall thickness throughout the part to understand the causes of the filling pattern. Run mold filling analysis, if justified, to define sources of high shear and flow hesitations and to define solutions.

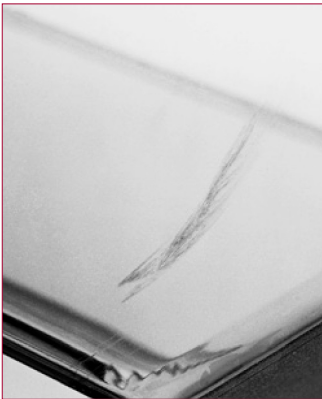
Heat splay

Possible cause	Corrective action
Hot spots in barrel, nozzle, or hot runner	Check actual melt temperature. Check actual barrel, nozzle, and hot runner temperatures. Check heater bands, thermocouples, and controllers.
Residence time too long	Ensure shot size 25%–75% of barrel capacity. Maintain melt residence time at <5 minutes. Check for dead spots in hot runners and nozzles.

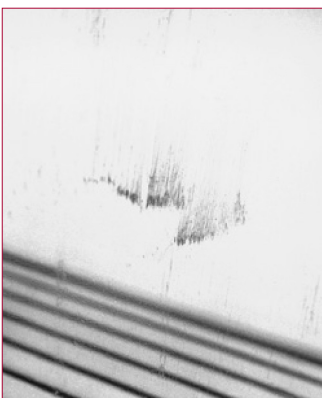
Possible cause	Corrective action
Improperly dried material (Note: Moisture splay is visible only when material is <i>extremely</i> wet.)	Ensure good drying. See processing guidelines for your copolyester formulations.

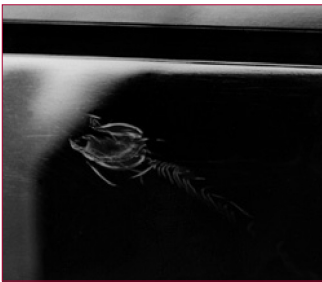
Other splay

Possible cause	Corrective action
Leaking check ring or high shear check ring or ball check	Repair or change check ring. Check for barrel wear.
Temperature differences in melt stream	Look for temperatures from check ring forward (cold slugs, nozzle drool, nonuniform nozzle temperature, hot runner internal temperature differences, etc.).
Cold slugs	Check nozzle, hot drop, and hot runner areas. Insulate or raise temperatures as appropriate.

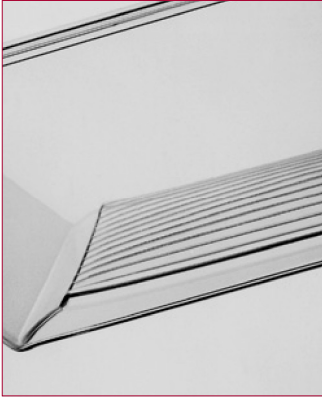
Warped or distorted parts as ejected from the mold

Possible cause	Corrective action
Hot spots or sticking during ejection	Locate hot spots (by pyrometer, etc.) and eliminate them by added cooling.
Undercuts	Locate undercuts (by finding part scratches or distortions) and eliminate them.
Insufficient ejector pins or lifters	Investigate part as it ejects to locate areas of weak ejection support and add ejectors.
Part overpacked	Reduce packing time/pressure.
Thick wall sections	Revise part wall thickness to be more uniform.
